This errata is applicable to the following devices:

- AT89S8252
- AT89LS8252
- AT89S53
- AT89LS53

### AT89S8252 AT89LS8252 AT89S53 AT89LS53 Errata Sheet

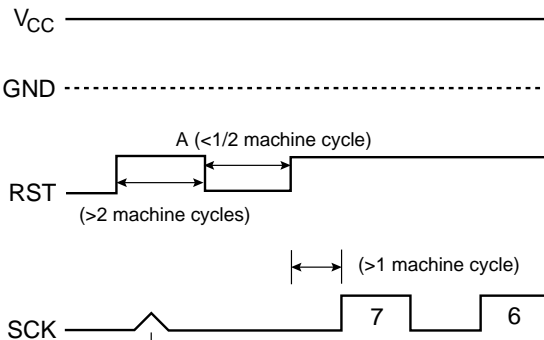
Regarding the in-system programming procedure, ATMEL currently recommends the following ISP waveforms for implementing the ISP programming algorithm in the AT89S-series devices:

( $V_{CC}$  should be powered up and stable PRIOR to the waveforms below)

This glitch MAY occur in certain systems because when RST goes high, port 1 pins will be driven with a strong pullup for one clock cycle; if the glitch does occur, it can be interpreted incorrectly as the first SCK pulse of a serial data stream. So the falling edge of RST at point A is necessary to "clean-up" the internal state machine.

These waveforms should be used in addition to the serial downloading waveforms shown in the respective device datasheets.
