# Intel<sup>®</sup> Pentium<sup>®</sup> III Processor Specification Update

Release Date: July 2002

Order Number: 244453-043

The Pentium<sup>®</sup> III processor may contain design defects or errors known as errata which may cause the product to deviate from published specifications. Current characterized errata are documented in this Specification Update.

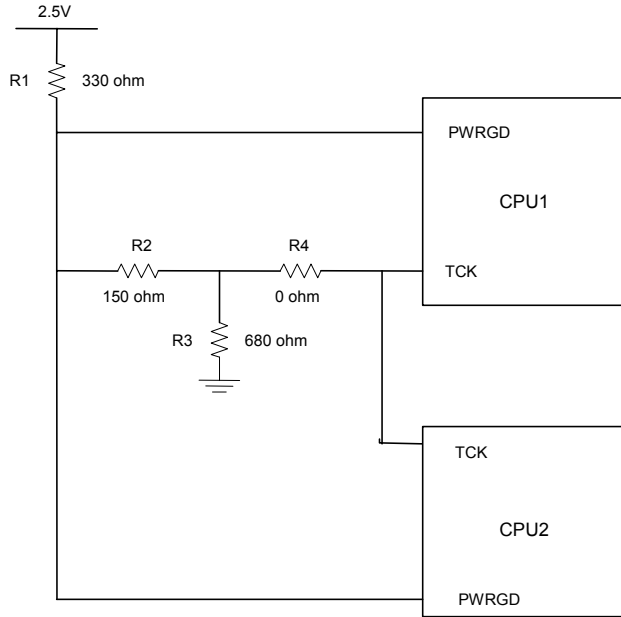
Pentium® III Processor with 512KB L2 Cache Platforms Workaround

In addition, the example workaround circuits shown do not support production baseboard test methodologies that require the use of the processor JTAG/TAP port. Alternative workaround solutions must be found if such test capability is required.

Assumes the inputs to the CPU\_PWRGD are open collector signals that are Wire-ANDed together

- The example workaround circuit assumes that the PWRGD inputs into the processors are open collector. Tying the PWRGD inputs together in a Wired-AND fashion allows each processor to receive PWRGD at the same time but at the latter of the 2 separate PWRGD assertions. If separation of the PWRGD inputs to each processor is required, extra circuitry will be required.
